# Soil Salinity as a Major Challenge for Sustainable Agriculture in the Low Desert of California

**Ali Montazar**

Irrigation and Water Management Advisor  
University of California ANR

2022 MSSC Annual Salinity Summit  
Las Vegas, February 24-25, 2022

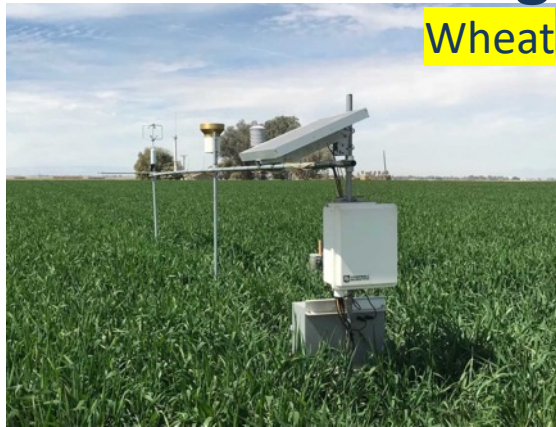
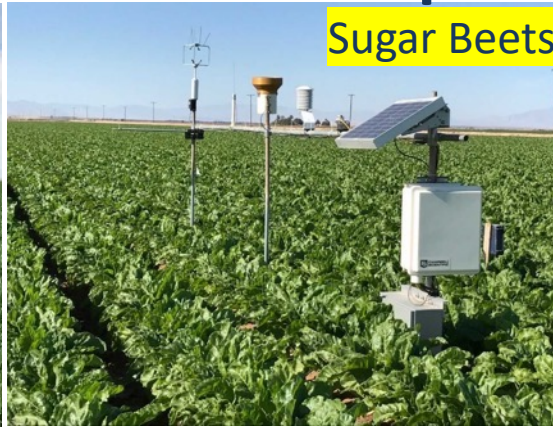
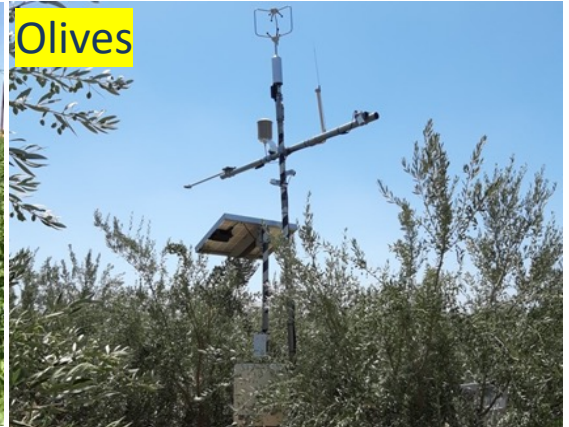
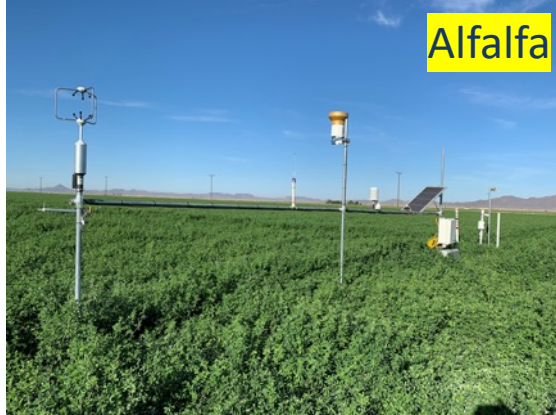
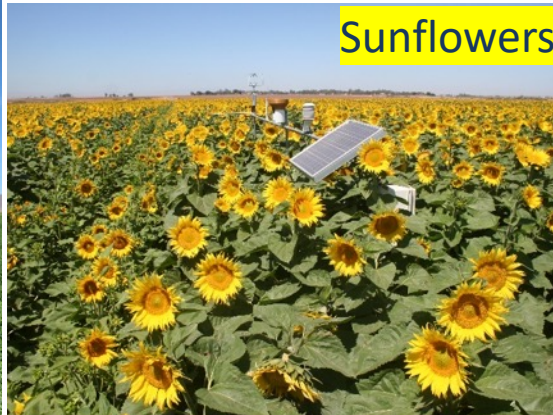
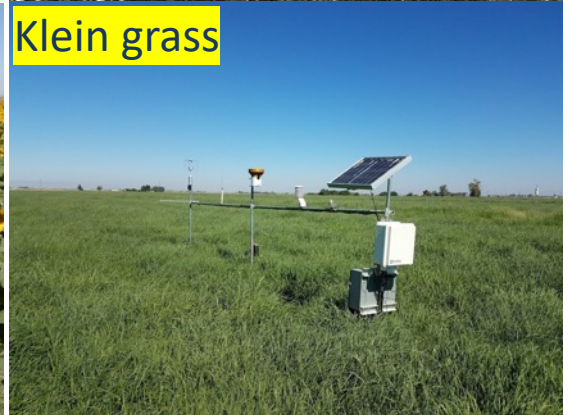
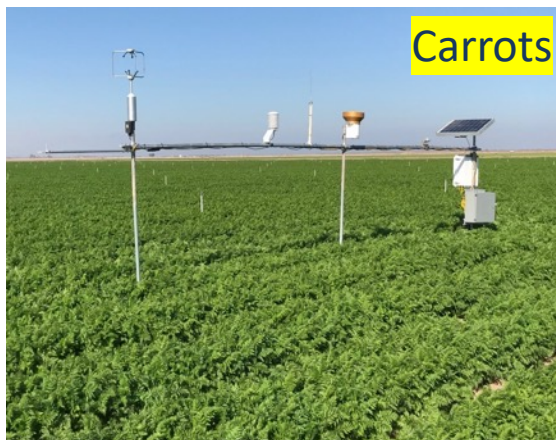
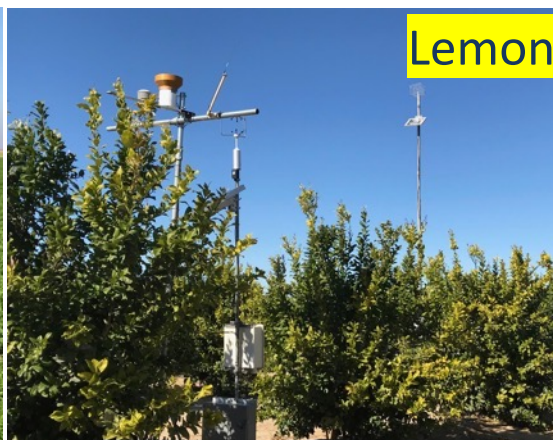
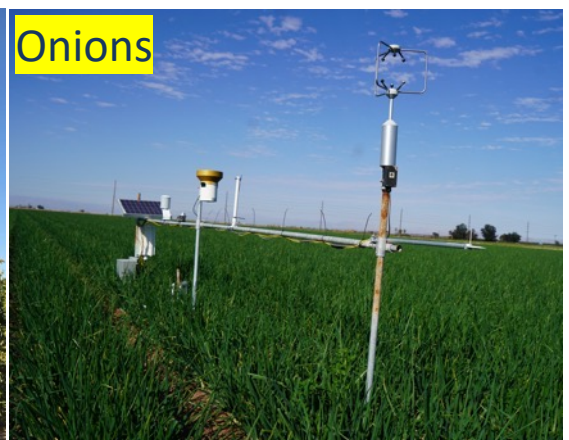
# Monitoring stations in experimental fields

- 78 commercial fields in the low desert of CA
- 12 various commodities including alfalfa, onions, carrots, lettuce, spinach, date palm, olives, lemon, sugarbeets, wheat, kleingrass, and sunflowers
- Various soil types and conditions
- Various irrigation practices (flood, furrow, solid-set sprinkler, drip, subsurface drip, linear-move sprinkler)

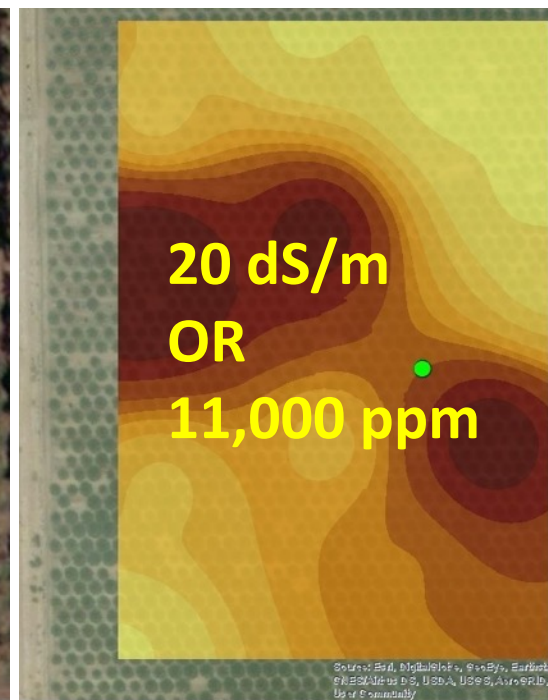
# Soil salinity map in date palms

1-2 ft. depth

EC<sub>e</sub> = 0.64 – 2.04 dS/m

0.77 – 7.62 dS/m

6.51 - 32.57 dS/m

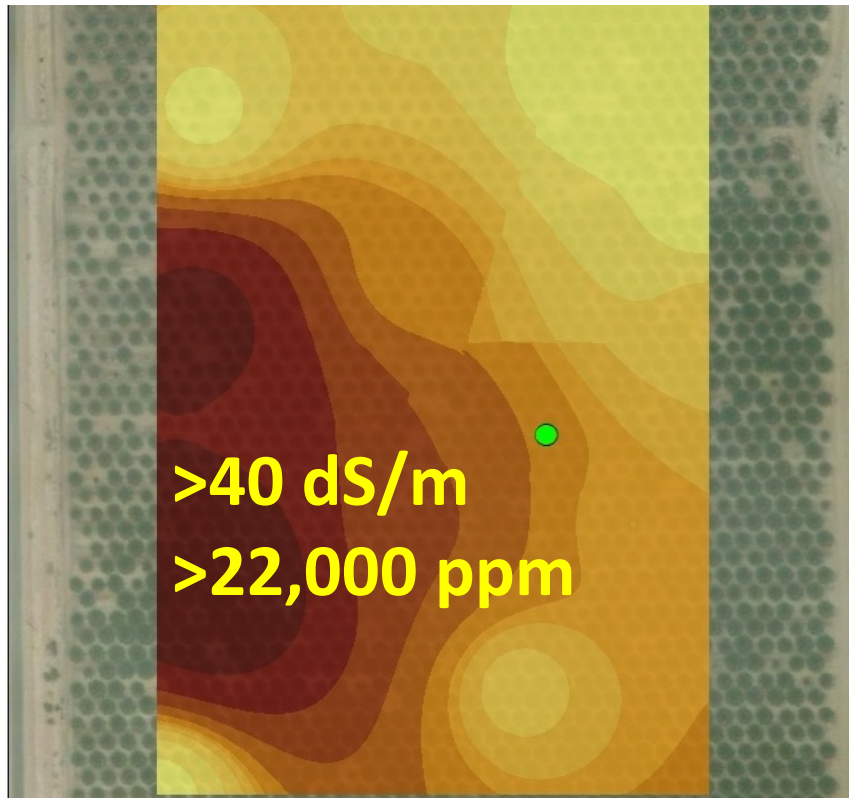
Soil salinity map  
(date palm located in  
Westmorland)

ECe varies from  
4.6 to 61.9 dS/m

**Drainage issue?**

3-4 ft. depth

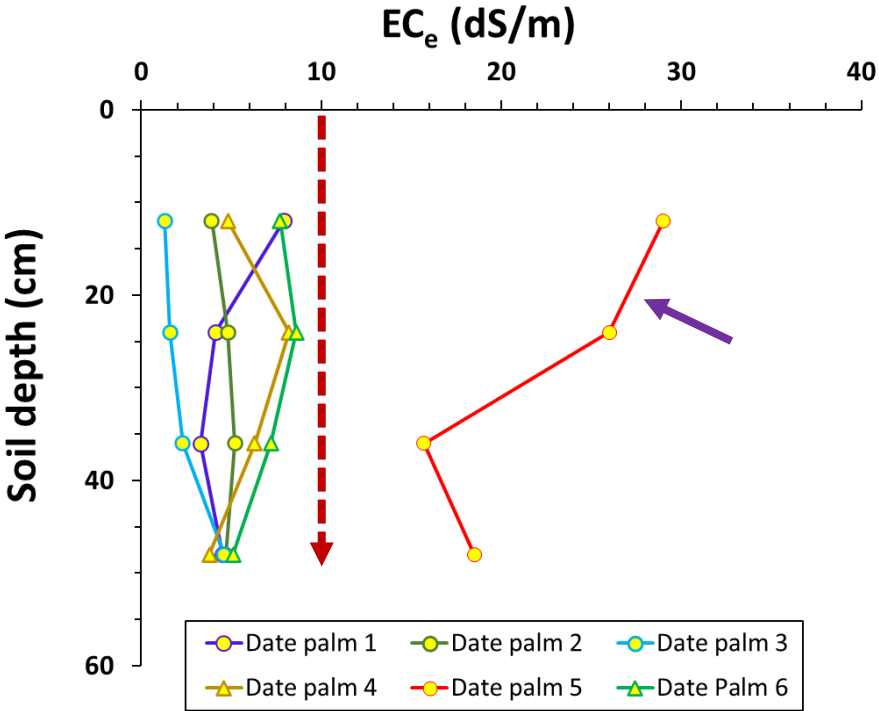
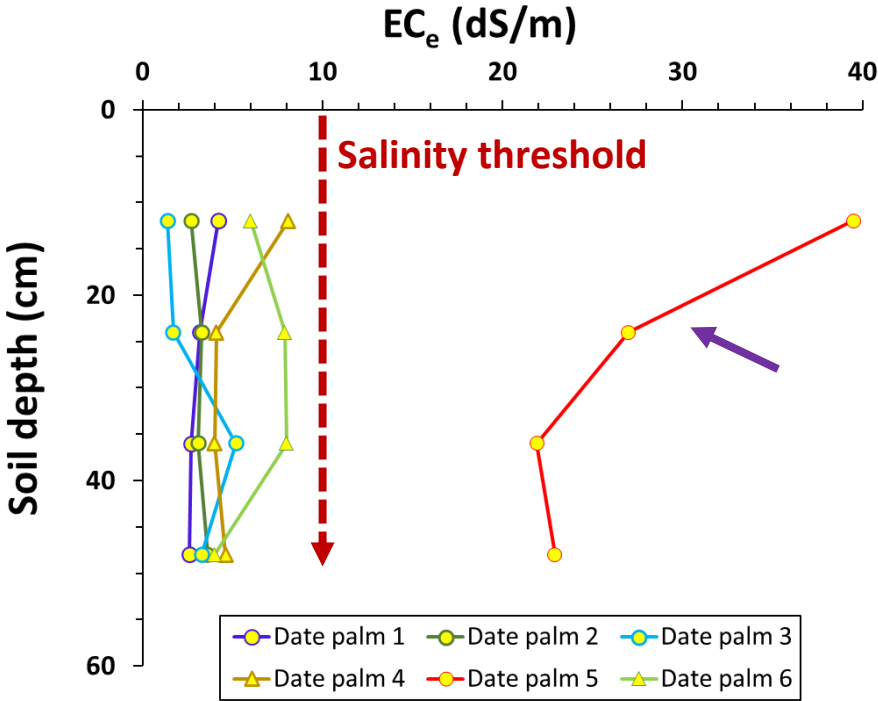
# Soil salinity within the soil profile (six date palms)

October, 2019

October, 2020

Date palm 5 located in Westmorland. This date palm has sodium hazard as well (SAR: 20-80)

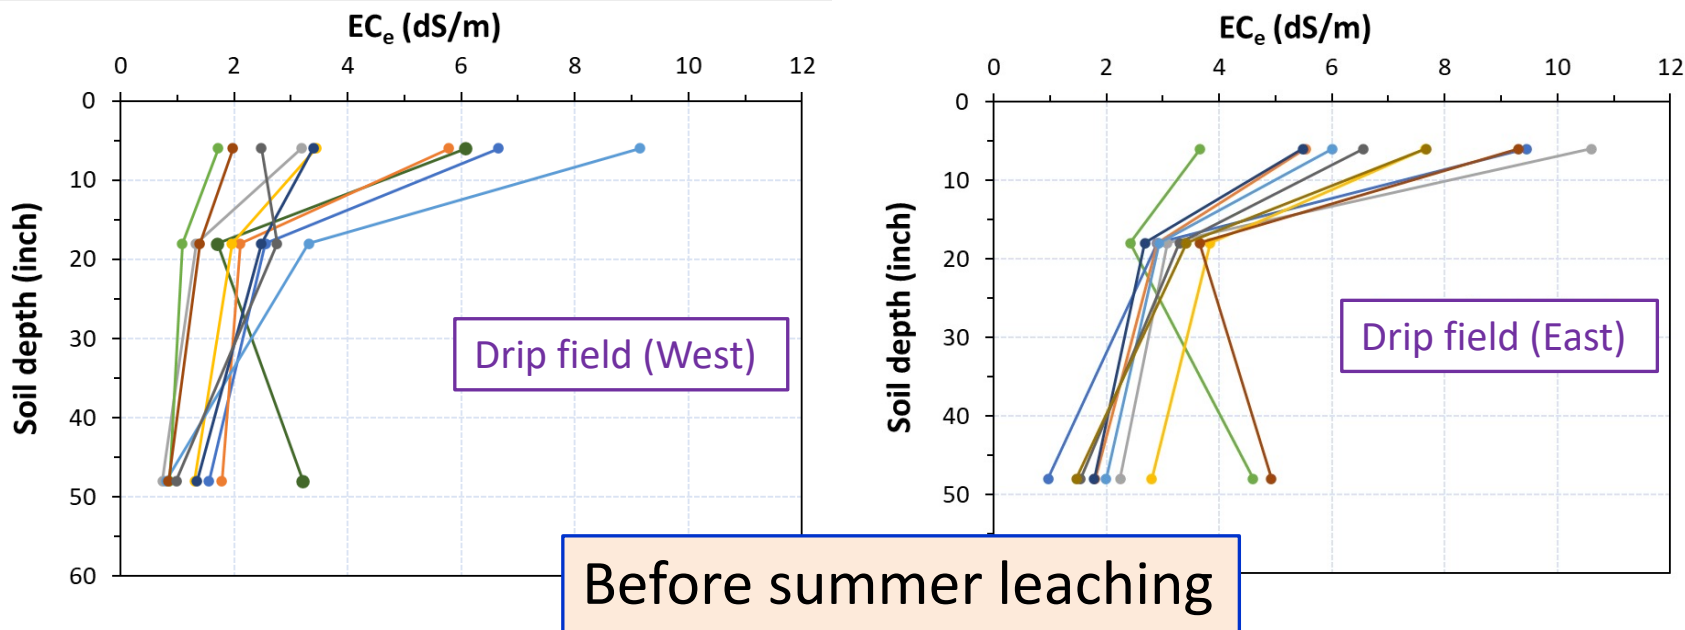
# Soil salinity within the soil profile (drip irrigated field-1)

- Higher level of salinity on the east side of the field
- High soil salinity on the topsoil
- Drain tiles work effectively

**Grower applied 90 lbs./ac Gypsum before planting.**

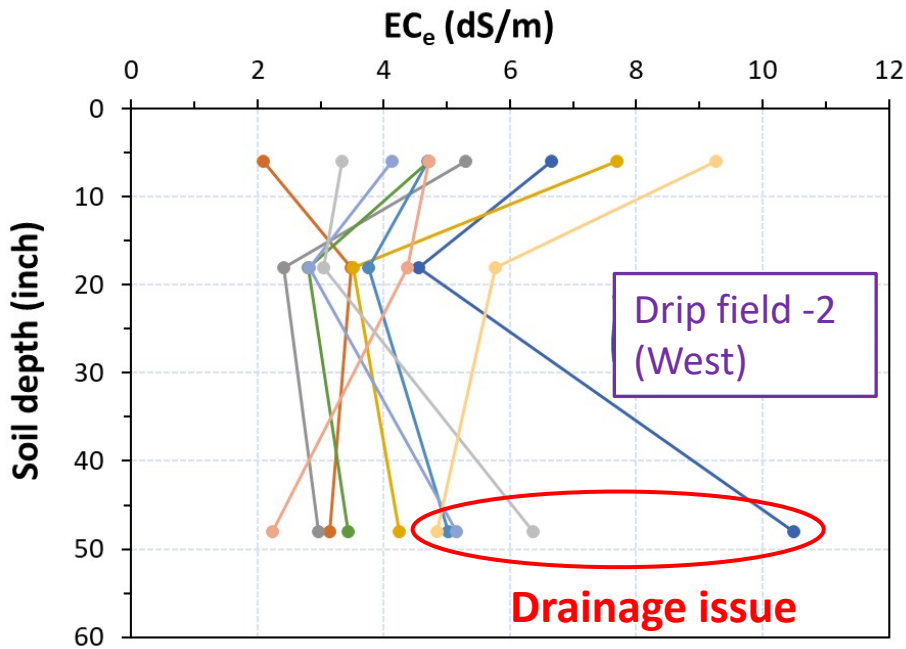
# Soil salinity within the soil profile (drip irrigated field-2)

Some tile drains could work effectively, some couldn't .

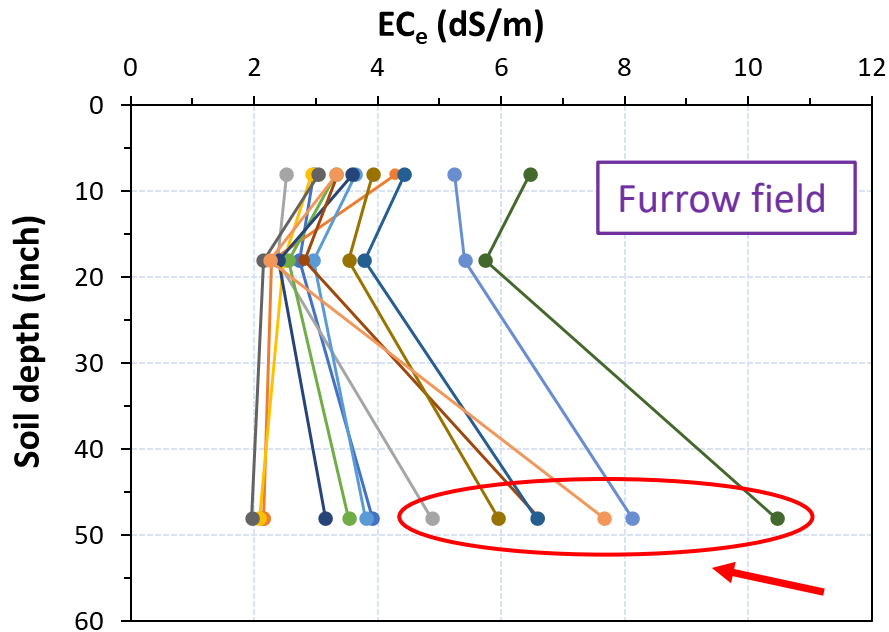
# Salinity assessment (furrow irrigated field)

(6-18 inches depth)  
Meloland and Holtville Loam

- A salt-affected field
- Drainage issue?

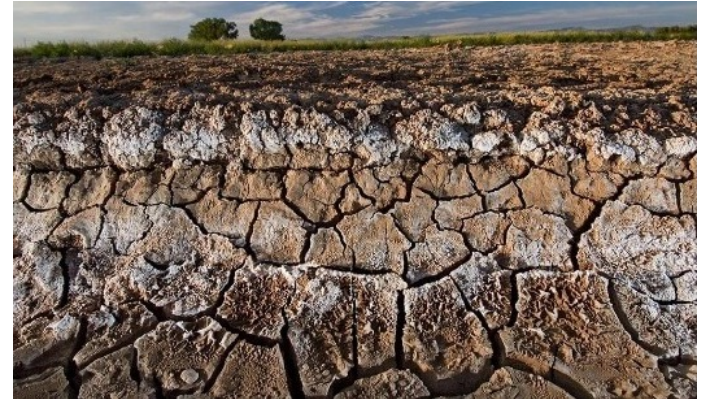
“**Land productivity** is highly depending on the effectiveness of salinity management.”

Salinity reduces actual crop water use and yields.

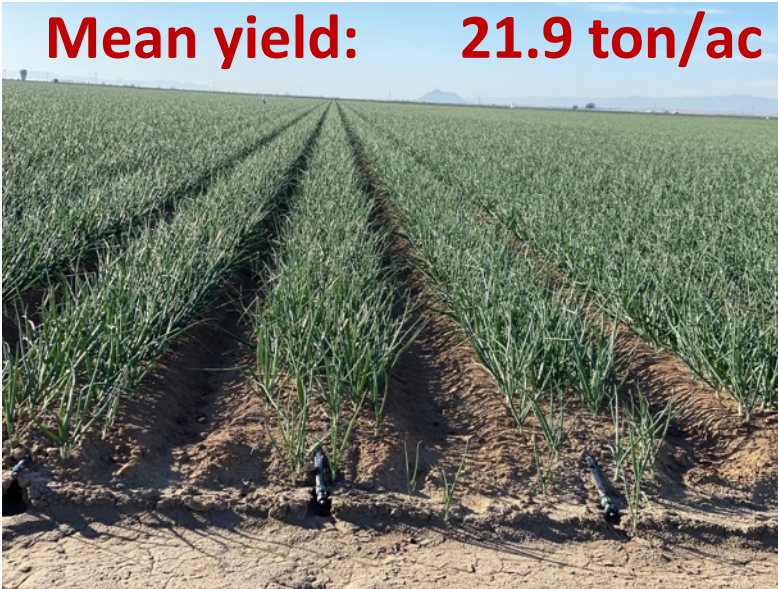
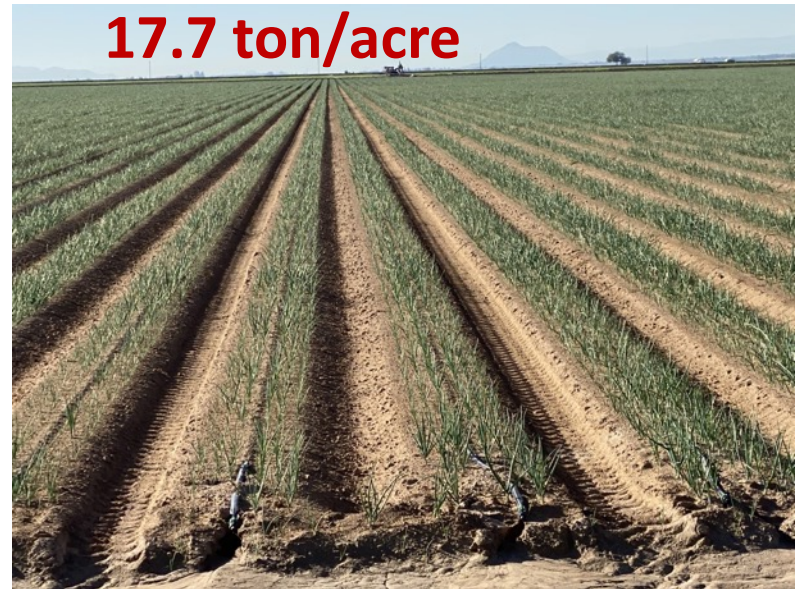
## Drip irrigated onion field (February 7, 2021)

**Mean yield: 21.9 ton/ac vs.**

**17.7 ton/acre**

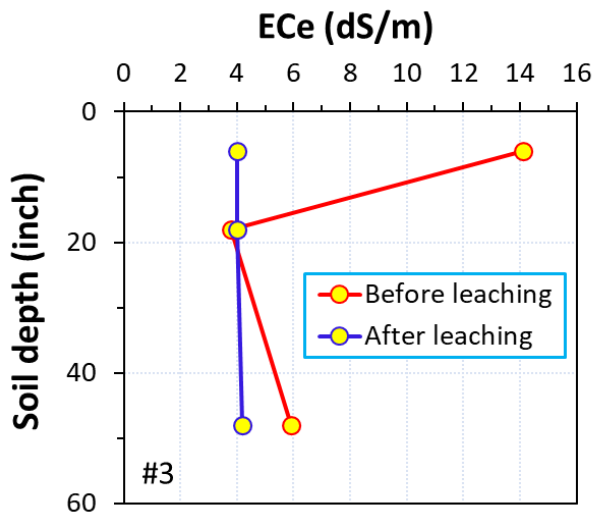
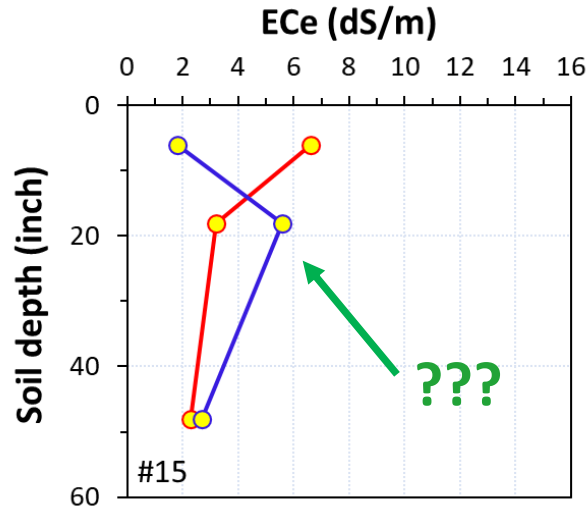
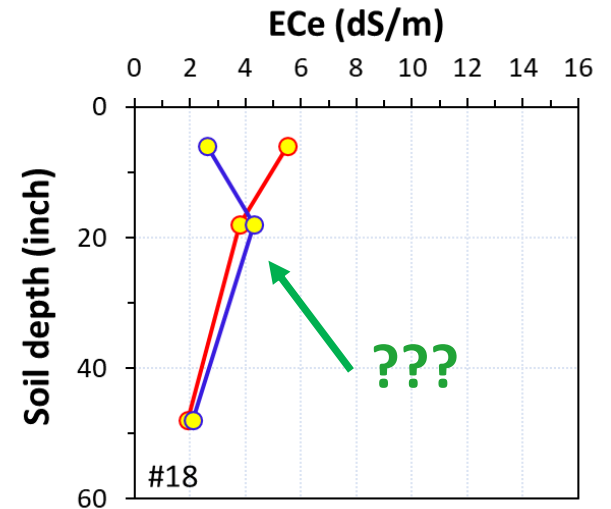
# Soil salinity before and after leaching

- This field was leached using sprinklers during September (data demonstrates salinity on SEP 24, 2021).
- Leaching was effective, but NOT completed.

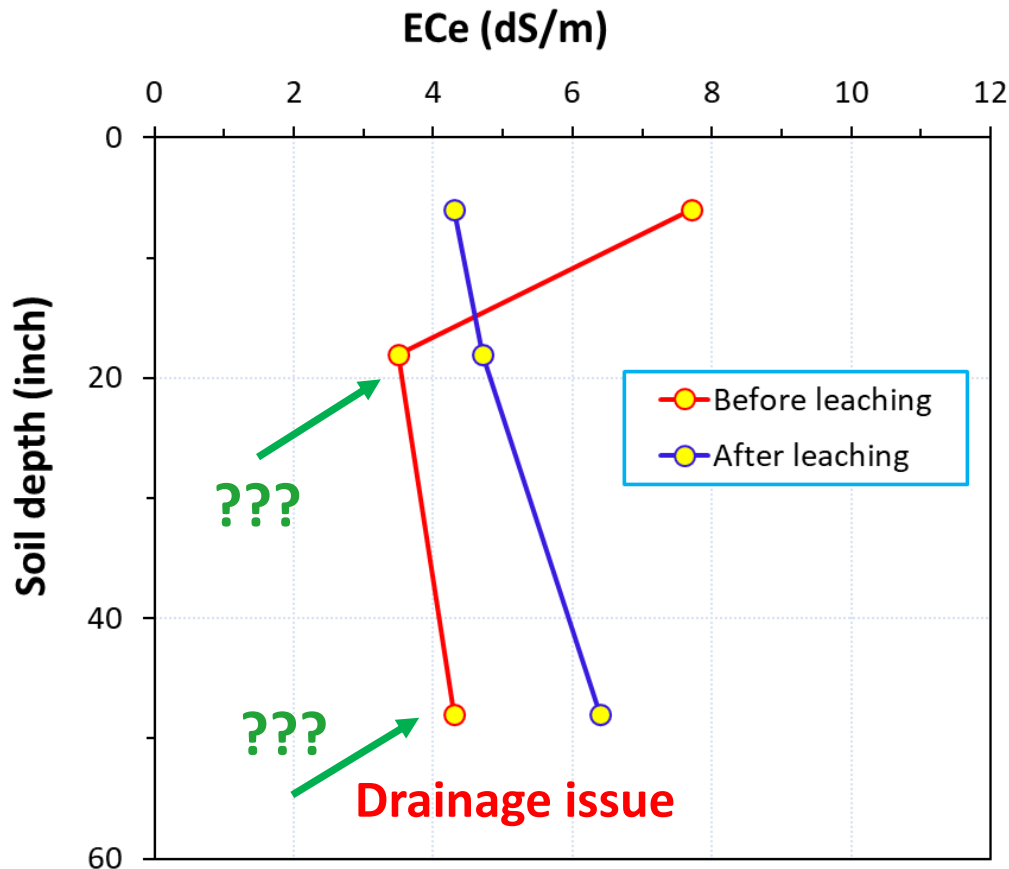
# Drip irrigated field with drainage issue

Drain tiles at 4-5 ft depth

Leaching (flood) won't be effective to sustain land productivity if drainage system doesn't work properly.

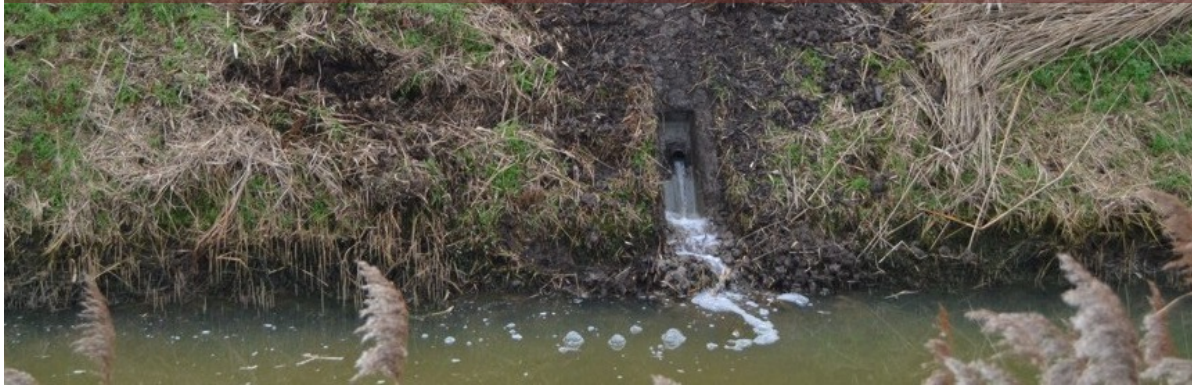
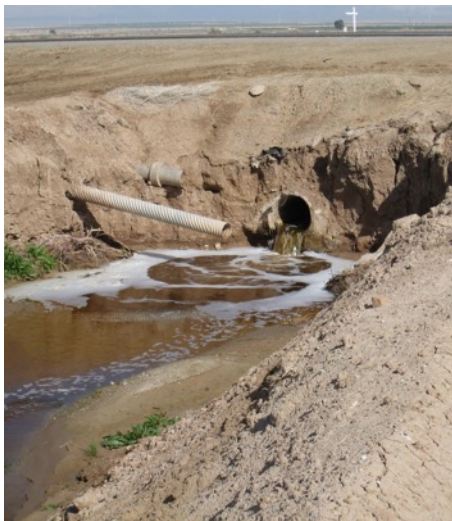
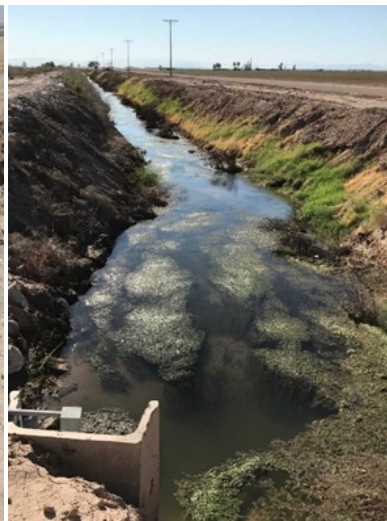
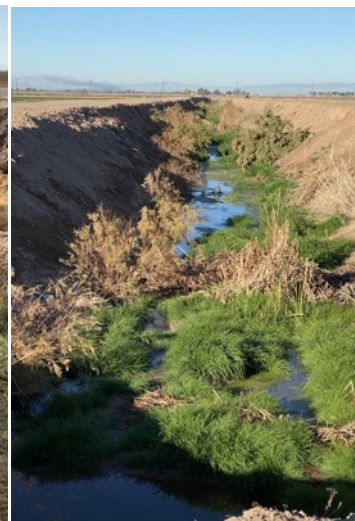
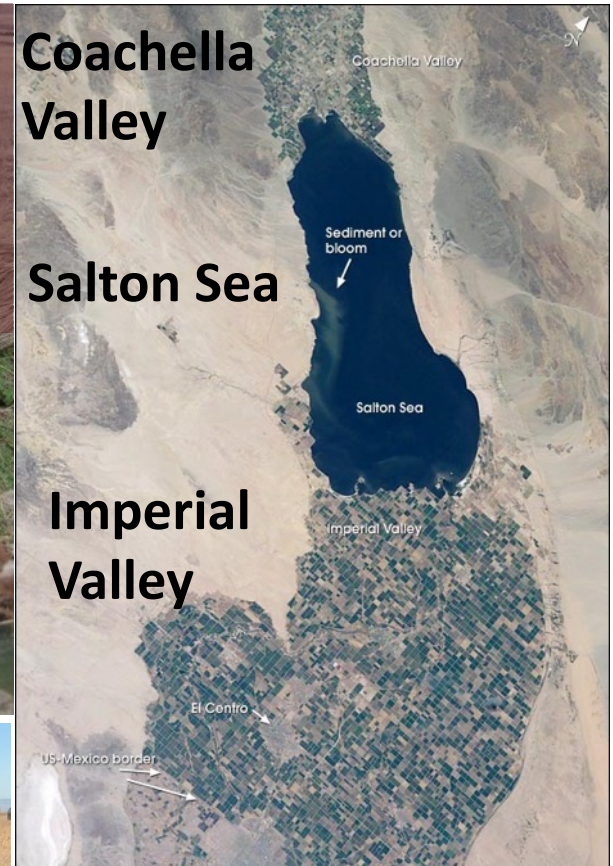
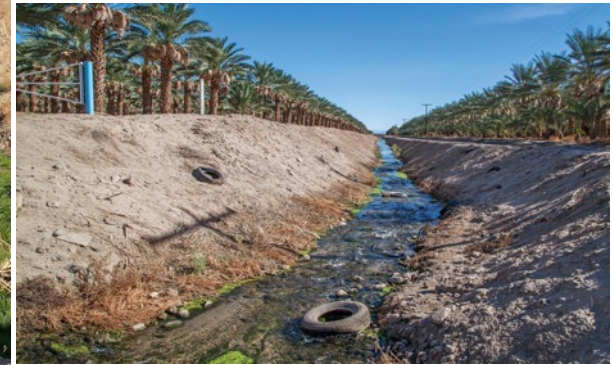
**Sub-surface drainage (tile) system delivers water to surface drainage system. All the drainage water (Imperial and Coachella Valleys) ends up in the Salton Sea.**

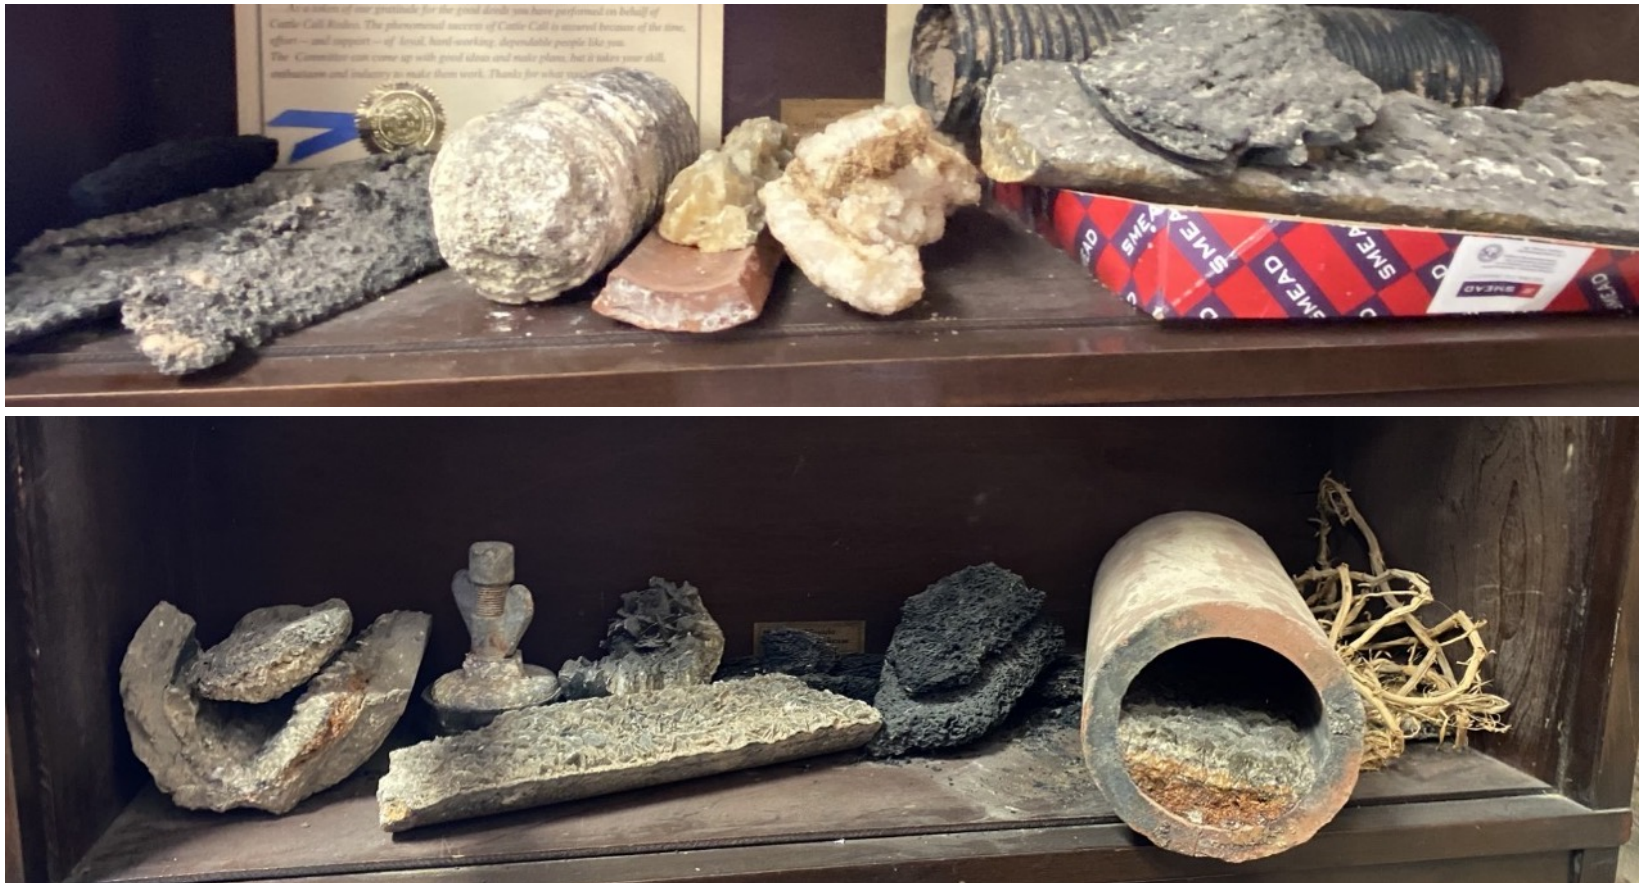
# Objects found inside tile drains in commercial fields (Imperial Valley)

Importance of maintaining drainage system!
